Concrete Surface Sealer

CASE STUDY: Industrial Bathroom Floor Solution Truck Manufacturing Plant – Elkhart, IN

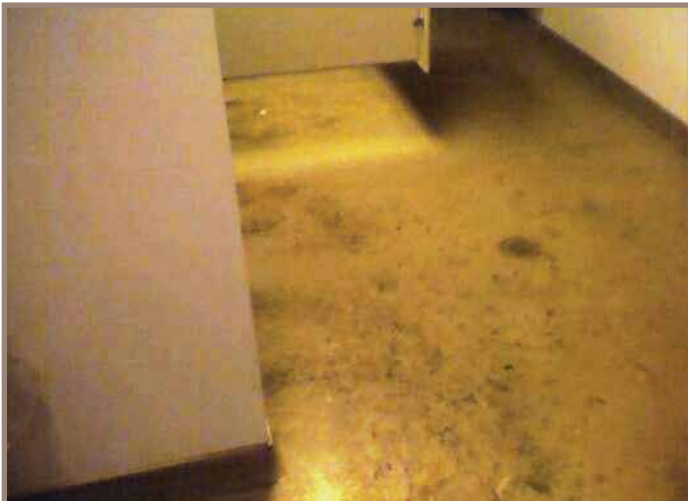
Before Treatment

Problem: Employees working in the spray booth were tracking paint overspray from epoxy, urethane and zinc-rich coatings onto the bathroom floors located adjacent to the spray booth. Maintenance could not remove the residues from these tracked coatings without also removing the epoxy floor paint.

Solution: Diamond grind floor surface to expose bare and stable concrete. Apply a self-leveling floor epoxy/quartz system to establish uniform base. Apply one coat of MicroGuard® AD703 Concrete Clear Gloss Treatment and allow to cure for 5 days.

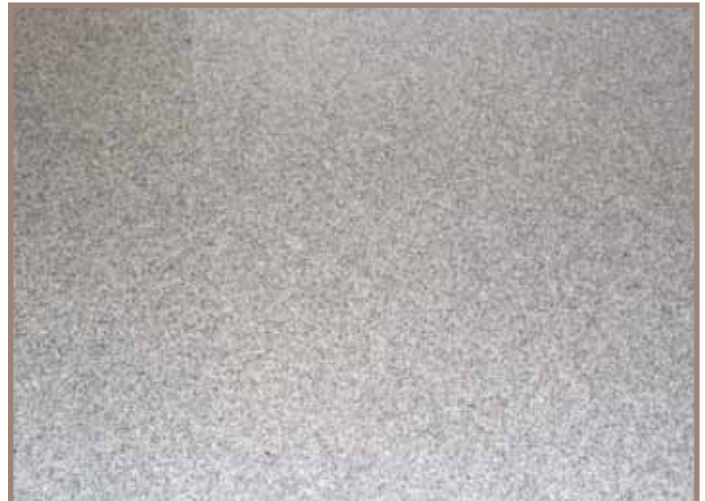
After treatment with MicroGuard® AD703

Results: Paint residues can now be removed using methylene chloride based paint stripper and without damaging the MicroGuard® clear treatment. Stripper residues are then removed using MicroKleen™ PLC-1 Cleaner & Degreaser.
