MICROGUARD[®]

Concrete Surface Sealer

CASE STUDY: Atlantic Beach, Florida Pool Deck

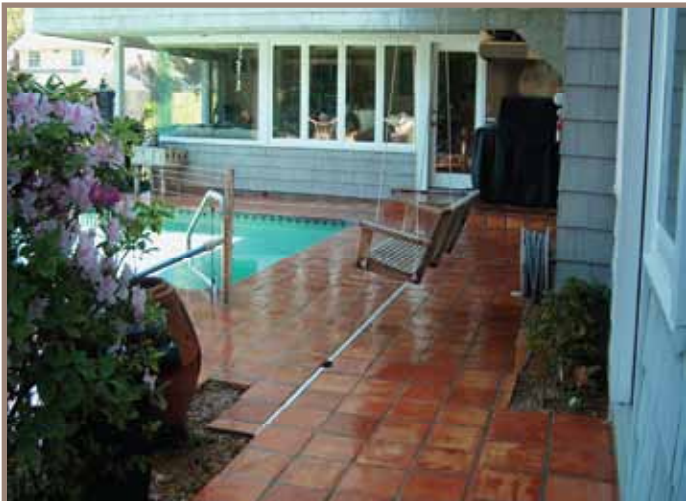
Before Treatment

Situation: Mexican tile pool deck was originally sealed by owner using an 'off-the-shelf', water-based, do-it yourself sealer product. The Water-Based Deck Coating turned white, became stained from spills, was very slippery, and resulted in a horrible appearance.

Solution: After stripping off the old sealer and cleaning the tile & grout, per Adsil published instructions, the deck was re-sealed using a two step process consisting of a first coat of MicroGuard[®] AD702 Sealer followed by a top coat of MicroGuard[®] AD703 Clear, which encapsulated the Microgrip[™] Anti-Skid Floor Media Additive.

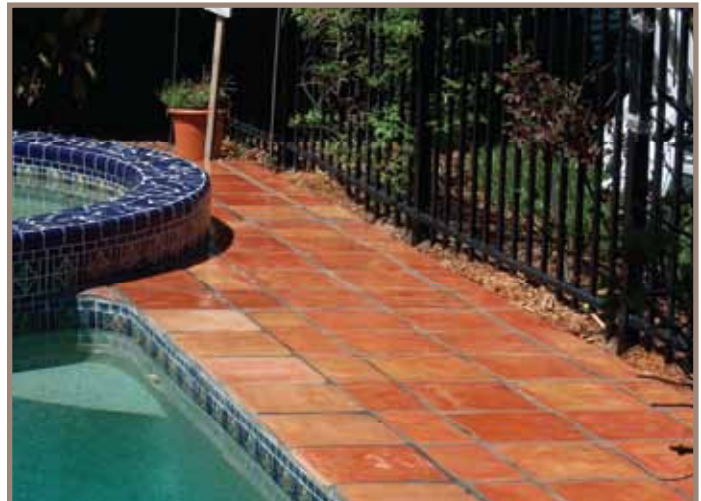
After treatment with MicroGuard[®] AD703

Results: Photos show how good the final results are with the MicroGuard[®]/ Microgrip[™] Anti-Skid System.
