Adsil®

Case Study:

GAIDOS SEAFOOD RESTAURANT

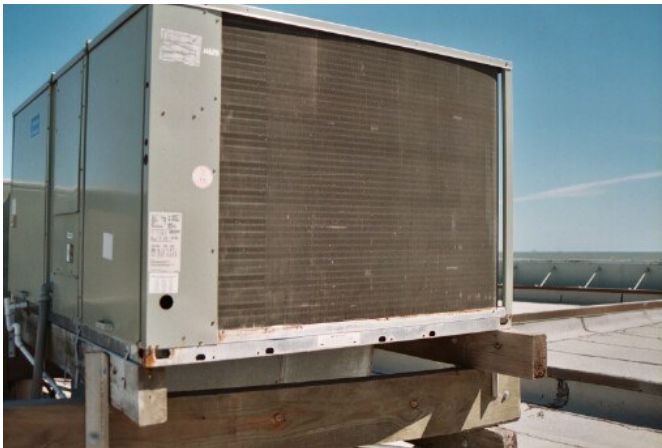
Cabinet shines like new!

After eighteen months the coils/fins, cases, fan blades are all in excellent condition. Fins are attached to coil tubes resulting in the retention of conductive heat transfer and designed energy efficiency. Fins are pliable and can be bent with out breaking or cracking.

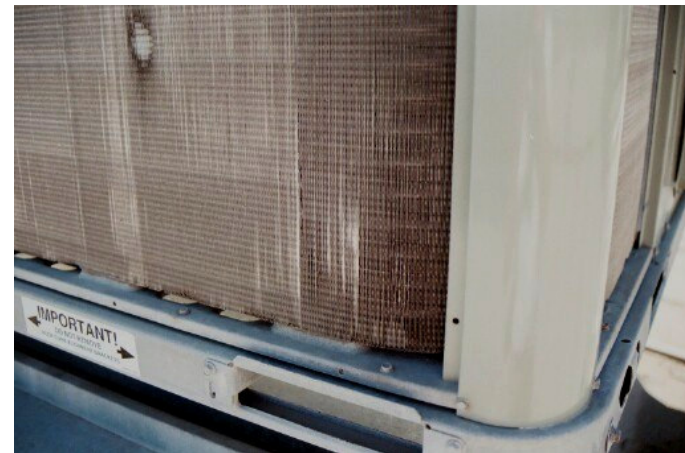
No corrosion on the coil edges!
